CHARACTERIZATION OF FATIGUE BEHAVIOR  
OF 2-D WOVEN FABRIC REINFORCED  
CERAMIC MATRIX COMPOSITE  
AT ELEVATED TEMPERATURE

THESIS

Daniel J. Groner, Captain, USAF

AFIT/GAE/ENY/94D-15

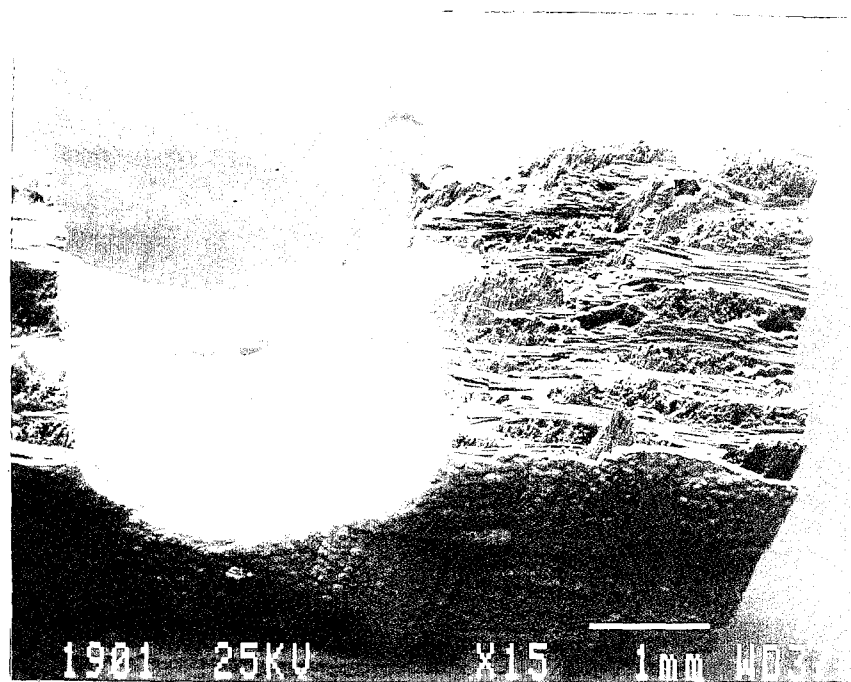
Figure 4-24 Scanning Electron Micrograph of Fracture Surface, 190 MPa Notched Test, 15X

The highest fatigue stress level notched test was the 190 MPa test. It cycled 95 times before failure. A view of the fractured specimen is shown in Figure 4-23. Figure 4-24 provides a 45° angular perspective view of the fractured surface and hole. The stress-strain curves at three specific

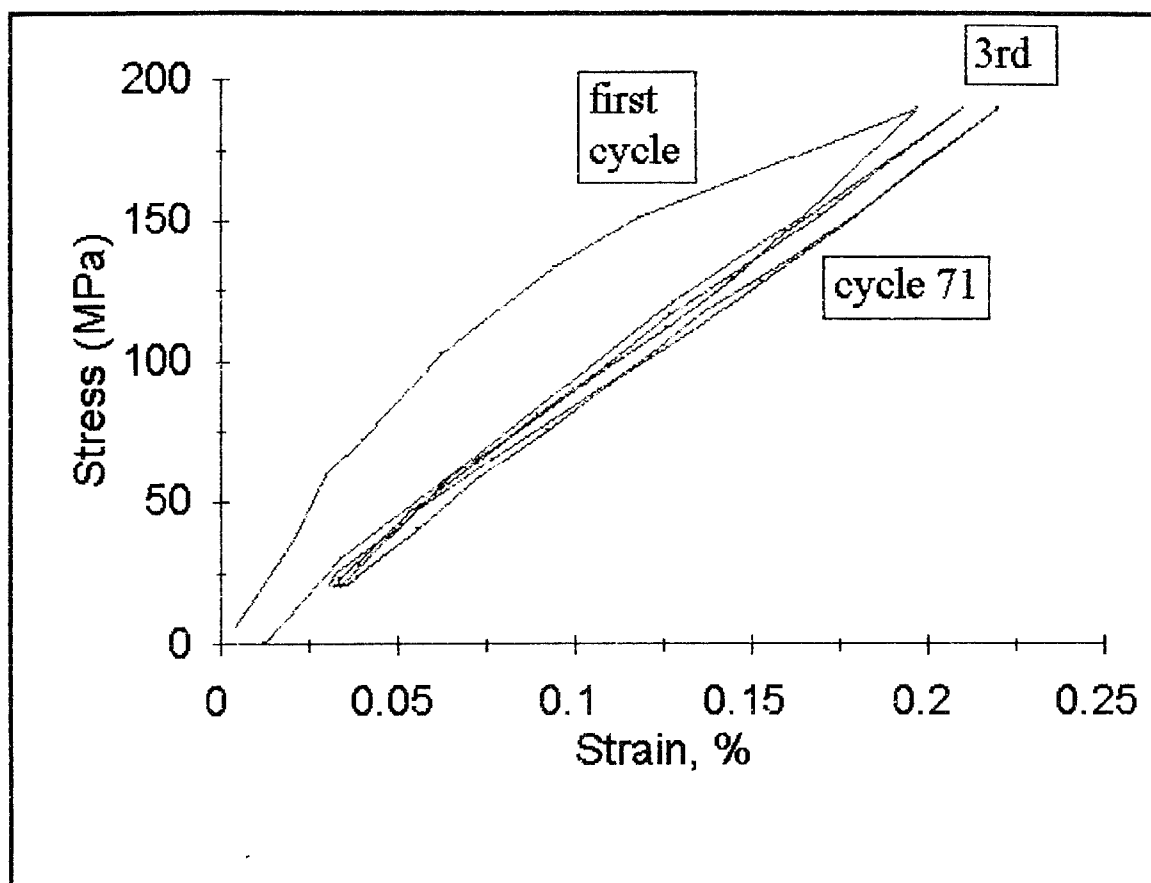
Figure 4-25 190 MPa Notched Stress-strain Curves

cycles of the 190 MPa test are presented in Figure 4-25. Here non-linearity of the stress-strain curve is much less pronounced than that exhibited in the unnotched tests due to

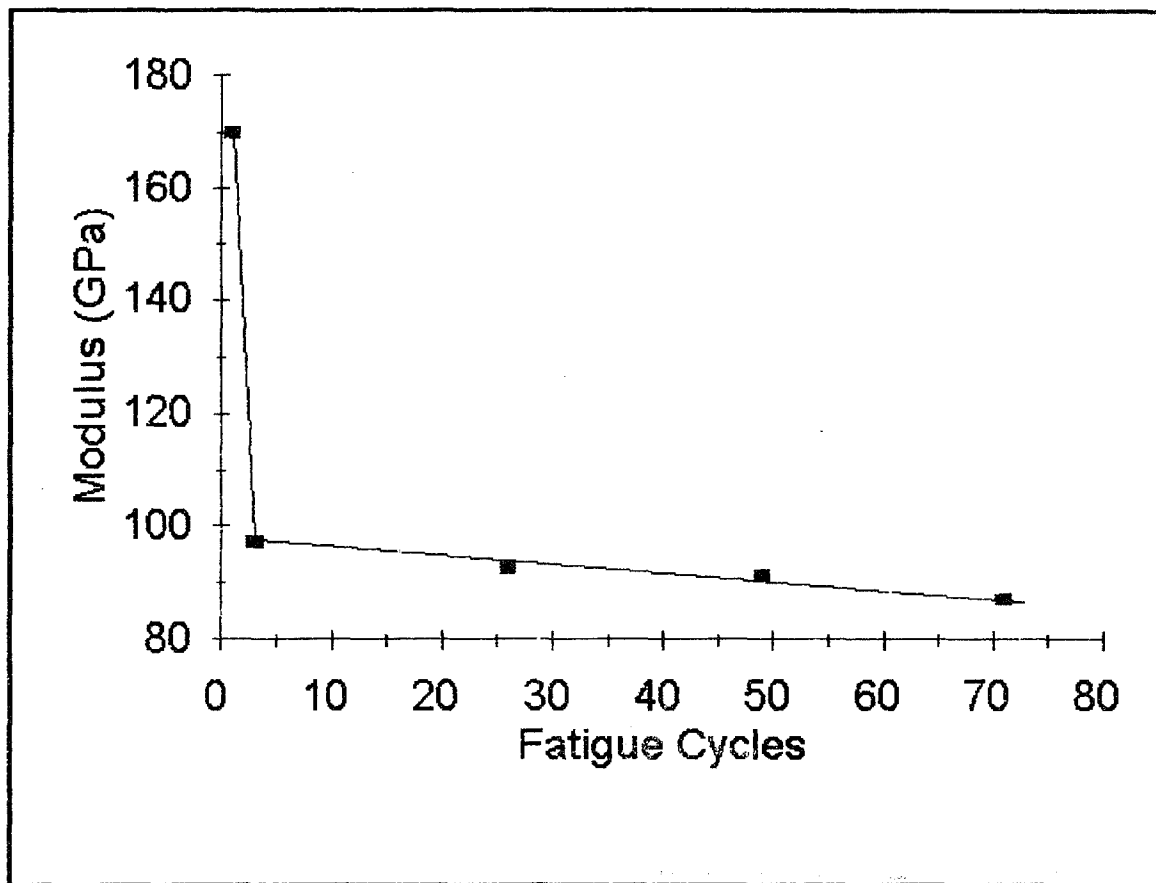
Figure 4-26 190 MPa Notched Test Stiffness Reduction

monotonic tensile test. Third cycle stiffness had fallen to 97 GPa showing a 45% degradation. The third cycle stiffness of 97 GPa also shows excellent correlation with the stiffness value of 95 GPa predicted by the monotonic tensile test discussion. Stiffness after this first cycle, diminishes slightly until failure.

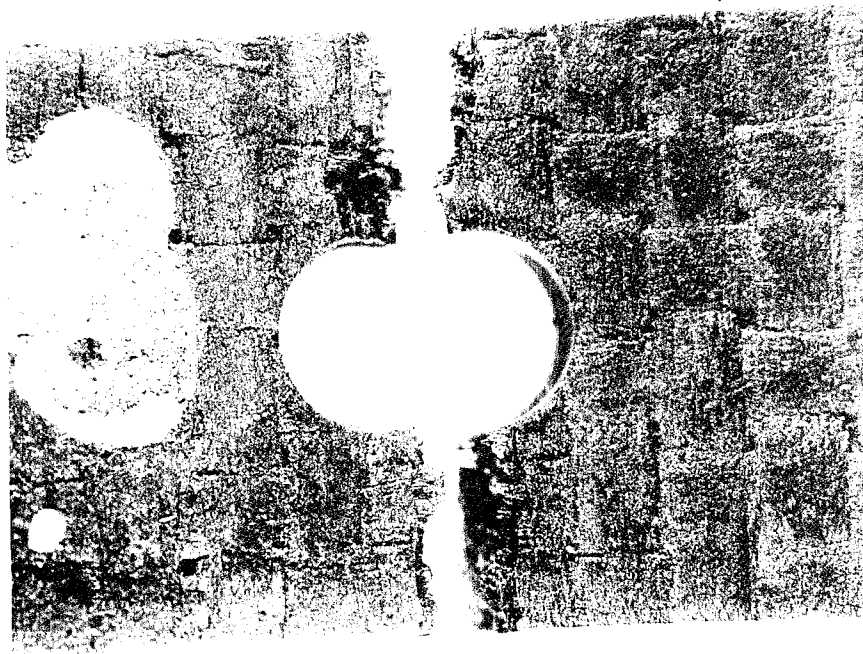
Figure 4-27 175 MPa Notched Fracture Surface, 8X Mag.

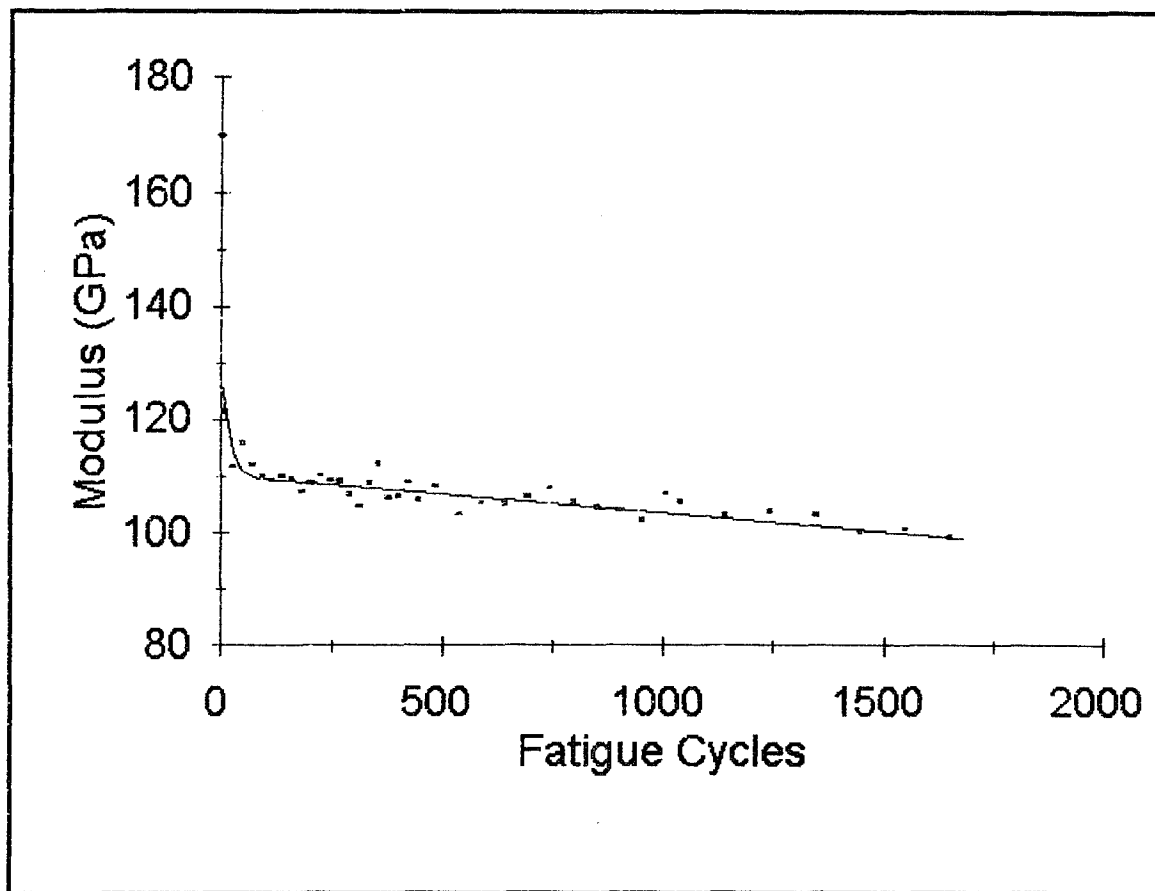
Figure 4-28 175 MPa Notched Stiffness Reduction

the stiffness reduction over the life of the test. This can be taken as evidence of the damage taking place during the test. Initial stiffness reduction of 34% is observed from 170 GPa in the static test to 112 GPa of the second cycle stiffness of this test. A further stiffness reduction, prior to failure, up to 90 GPa takes place over the life of the test. This stiffness magnitude at failure correlates with the 190 MPa notched test which also had a stiffness of approximately 90 GPa at failure. The 175 MPa notched specimen stress-strain curves are presented in Appendix B along with all other notched test stress-strain curves not included in this section.

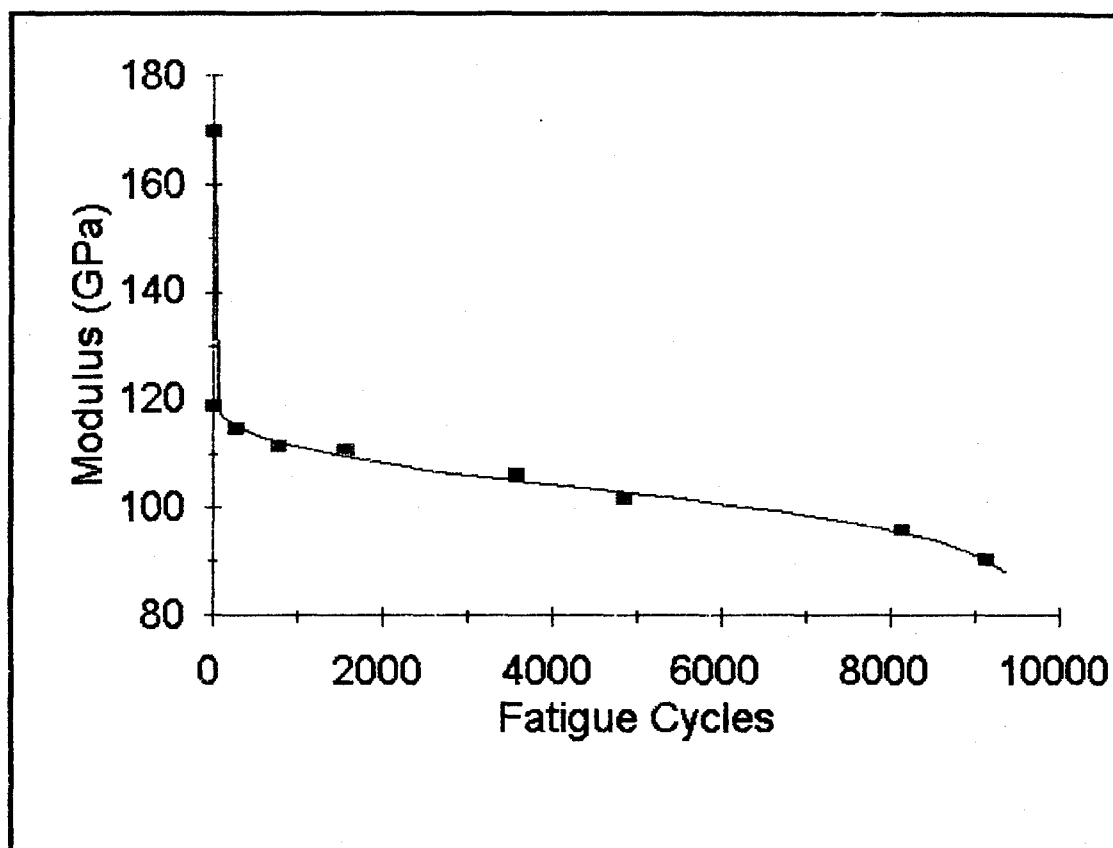
Figure 4-30 150 MPa Notched Stiffness Reduction

The results of the 150 MPa stress notched fatigue test are presented next. This test cycled 9,687 times before specimen failure. A view of the fractured specimen is shown in Figure 4-29. Figure 4-30 shows the stiffness reduction over the life of the test. This stiffness reduction is evidence of the damage taking place during the test. Initial stiffness reduction of 29% is observed from 170 GPa of the static test to 120 GPa which is the stiffness after the first fatigue cycle of this test. After the pronounced loss of stiffness in the first

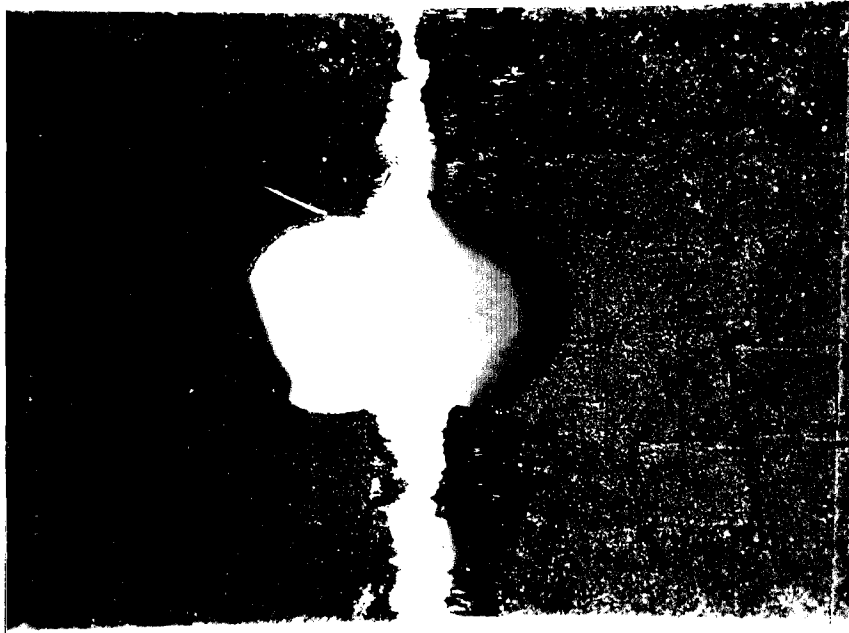
Figure 4-31 125 MPa Notched Fracture Surface, 8X

The next stress level notched fatigue test was the 125 MPa test. It cycled 19,544 times before failure. A magnified view of the fractured specimen is shown in Figure 4-31. Figure 4-32 plots the stiffness reduction over the life of this test. This stiffness degradation is evidence of the microstructural damage

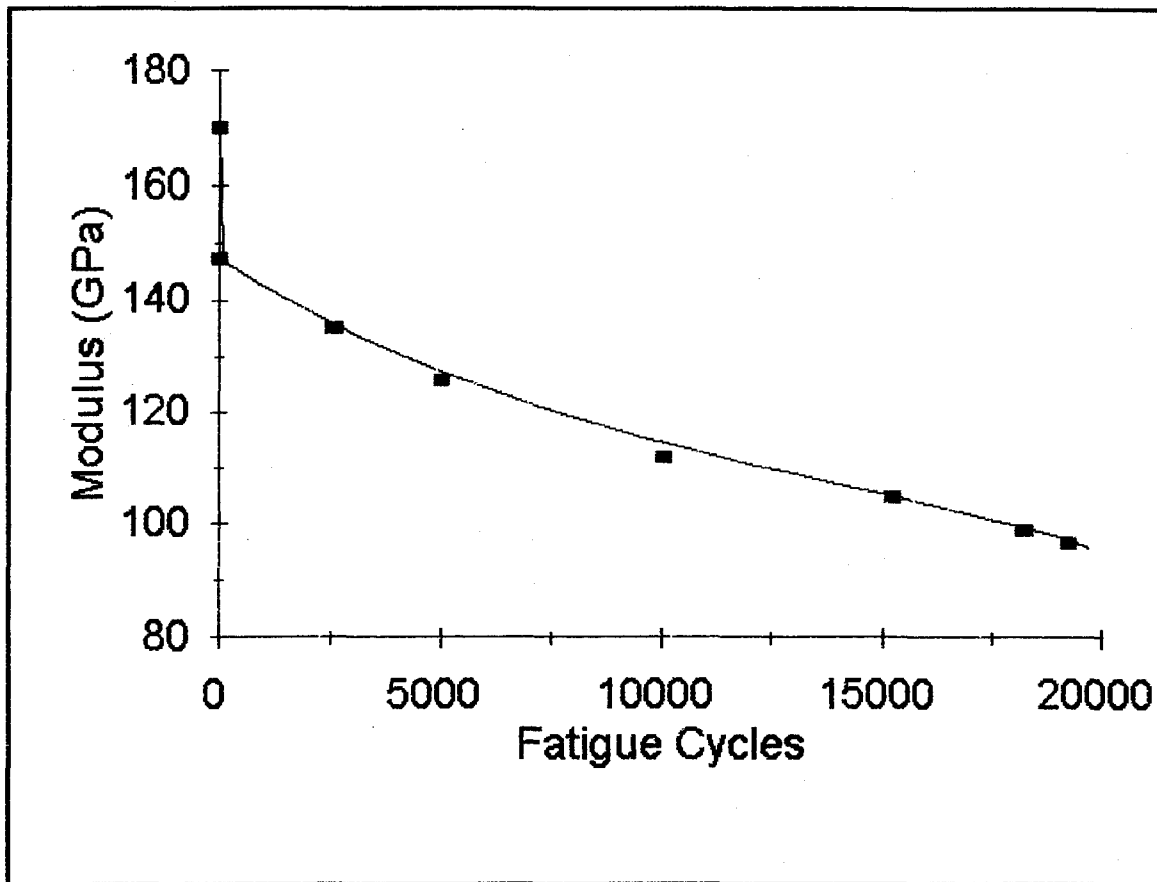
Figure 4-32 125 MPa Notched Stiffness Reduction

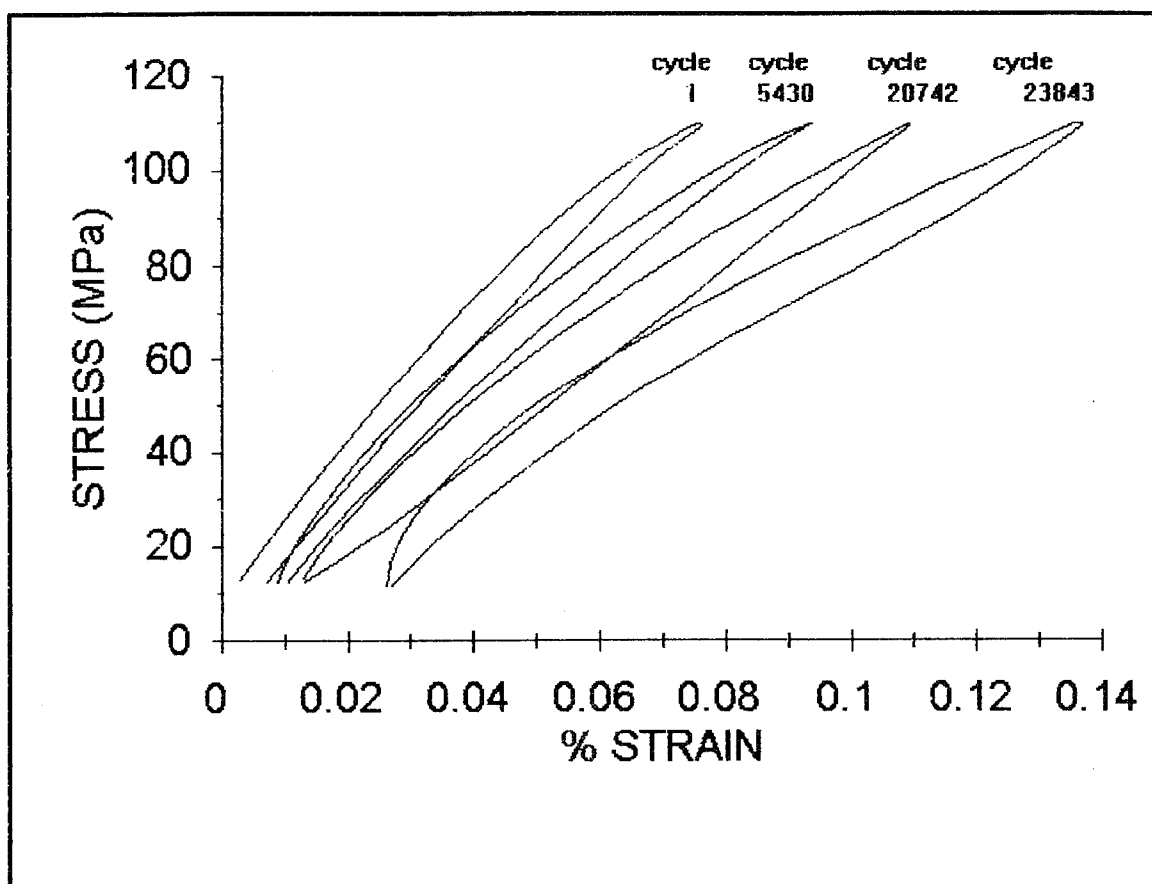
Figure 4-34 110 MPa Stress-strain Curves

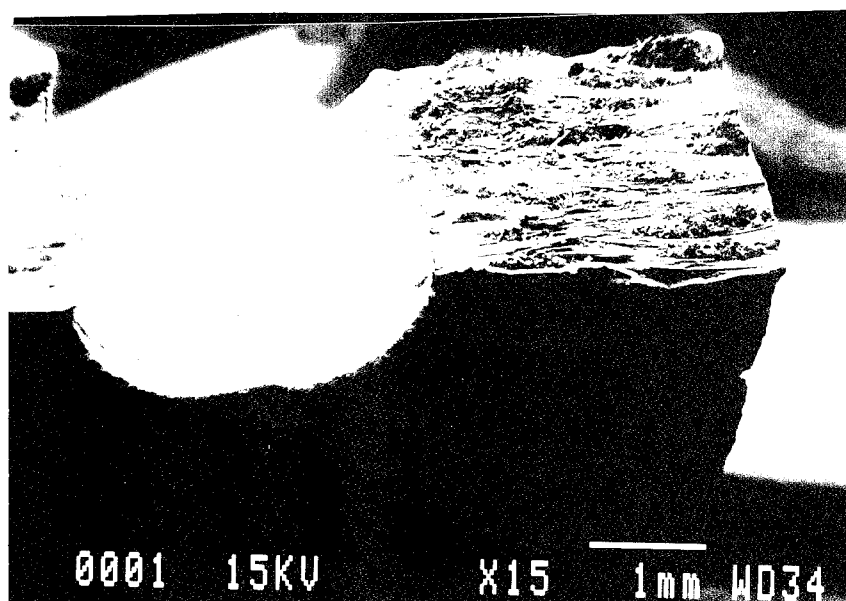
Figure 4-35 110 MPa Notched Test Micrograph of Fracture Surface, 45° Angle, 15X

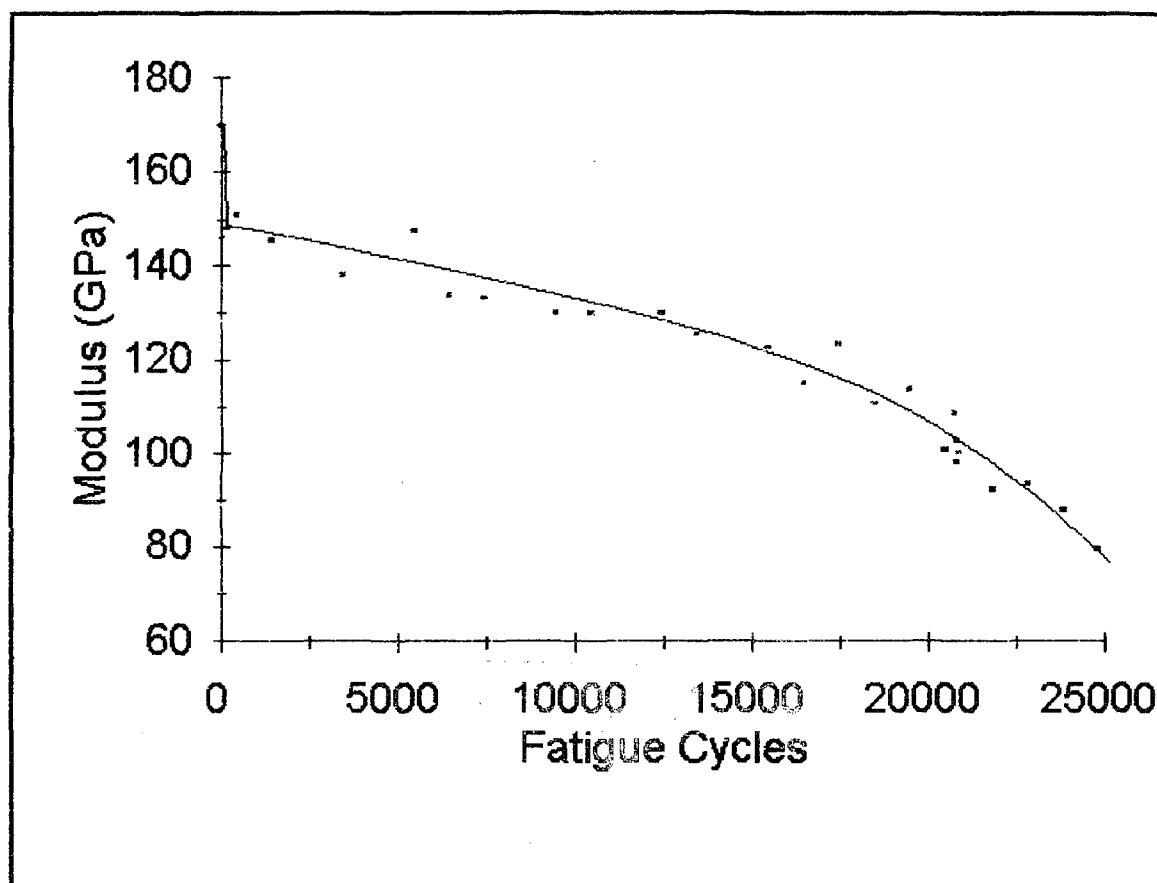
Figure 4-36 110 MPa Stiffness Reduction

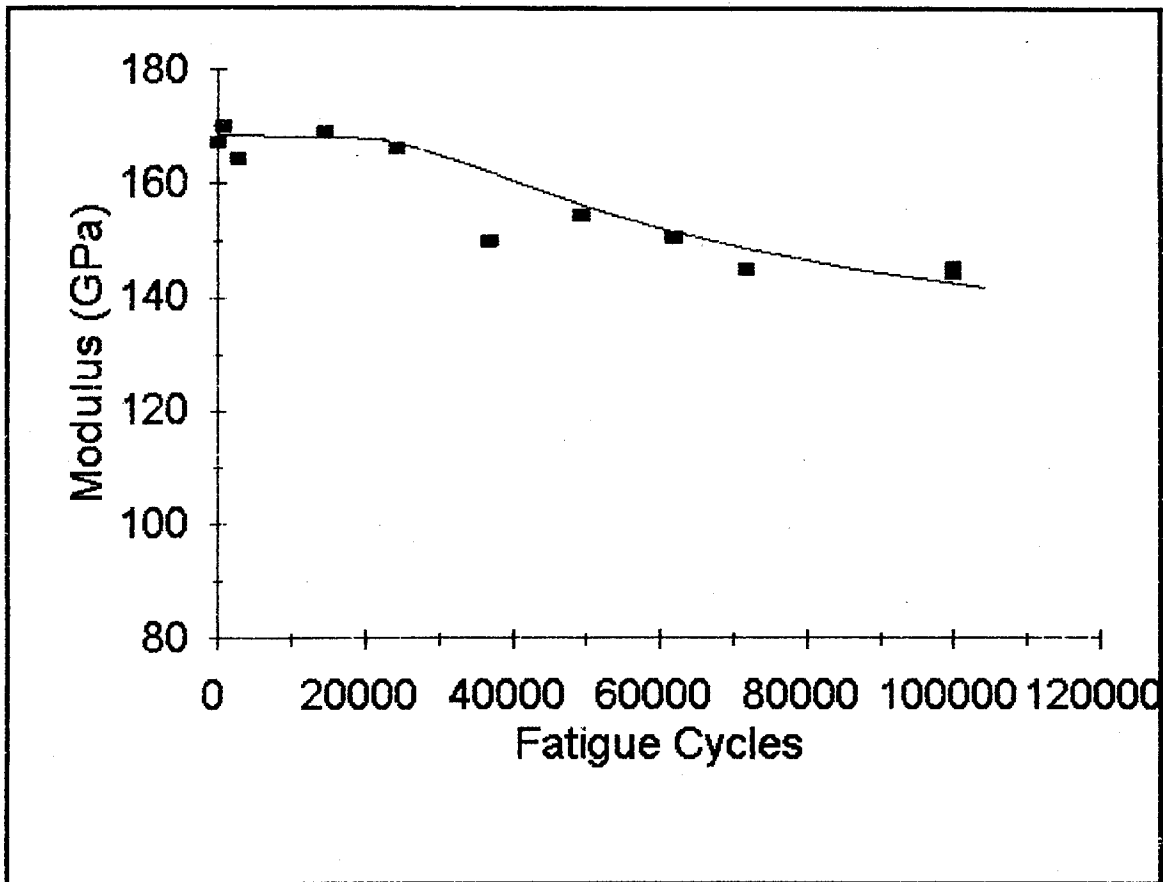
Figure 4-38 100 MPa Notched Stiffness Reduction

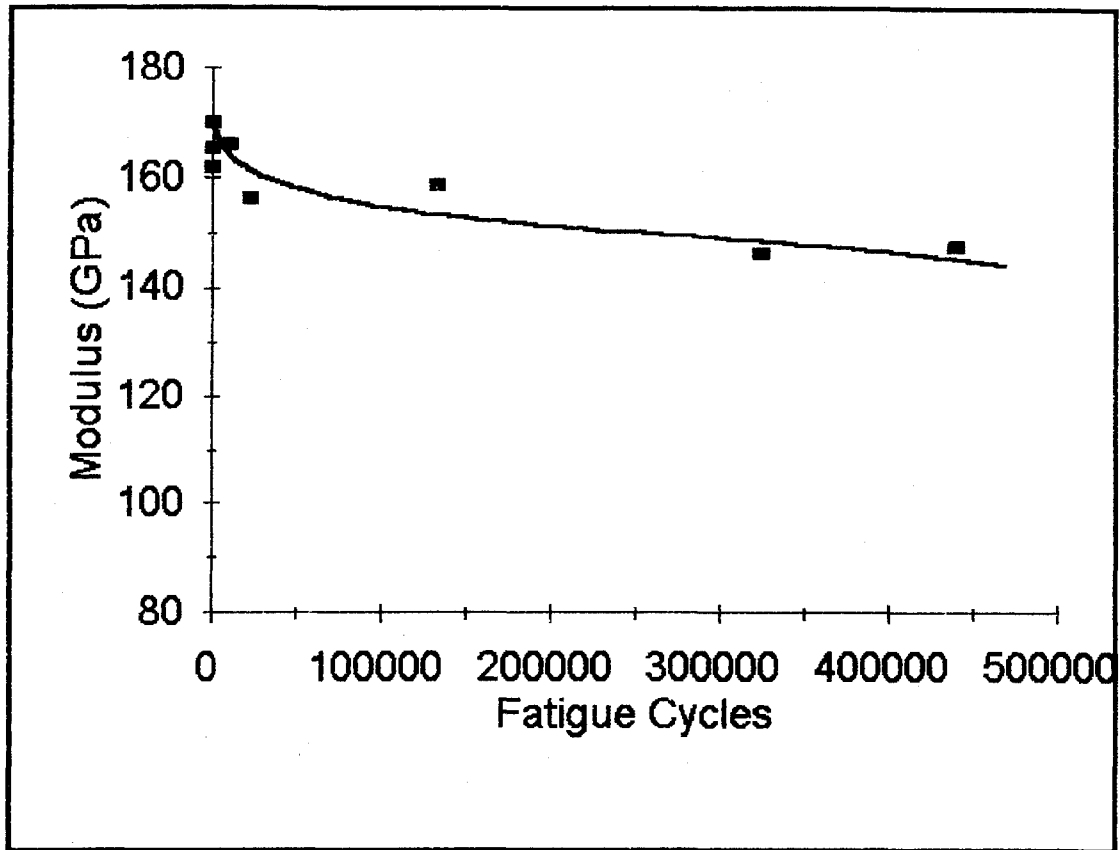
Figure 4-39 95 MPa Notched Stiffness Behavior

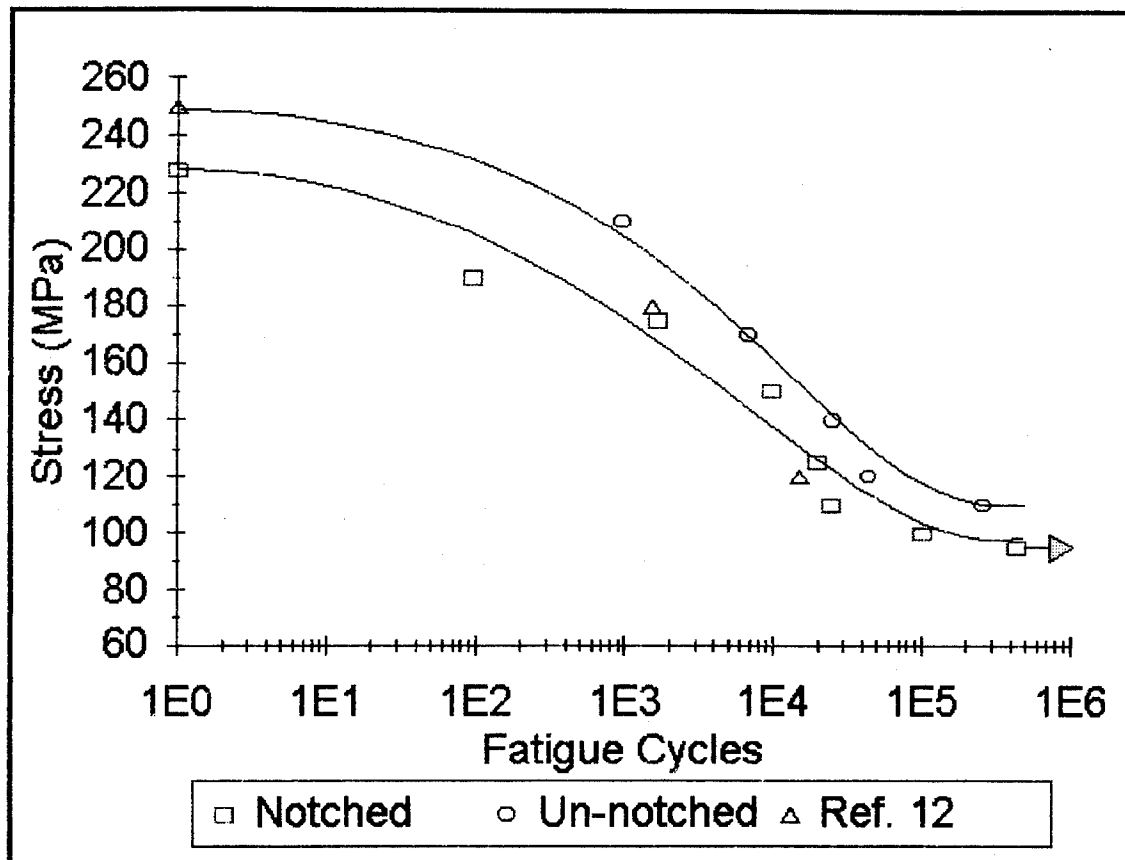
Figure 4-40 Fatigue Life Diagrams Including Monotonic Tensile Test Data Points

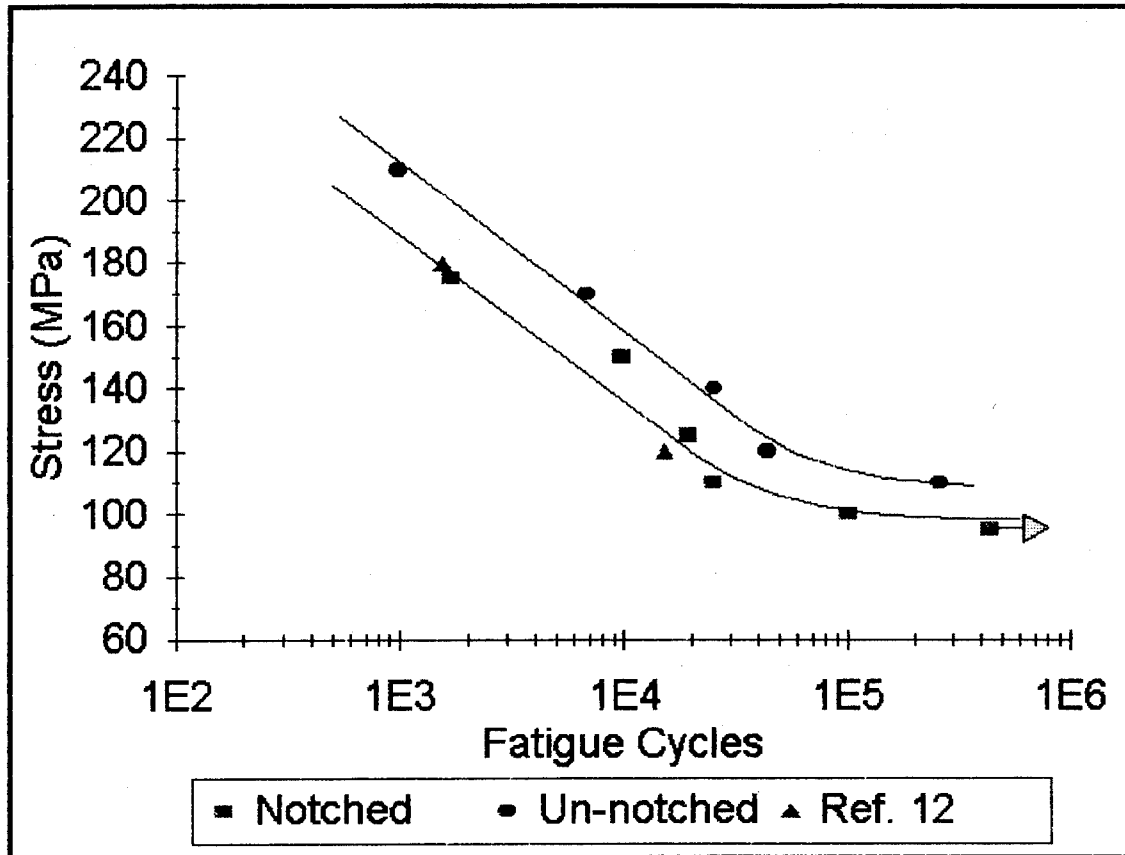
Figure 4-41 S-N Curves

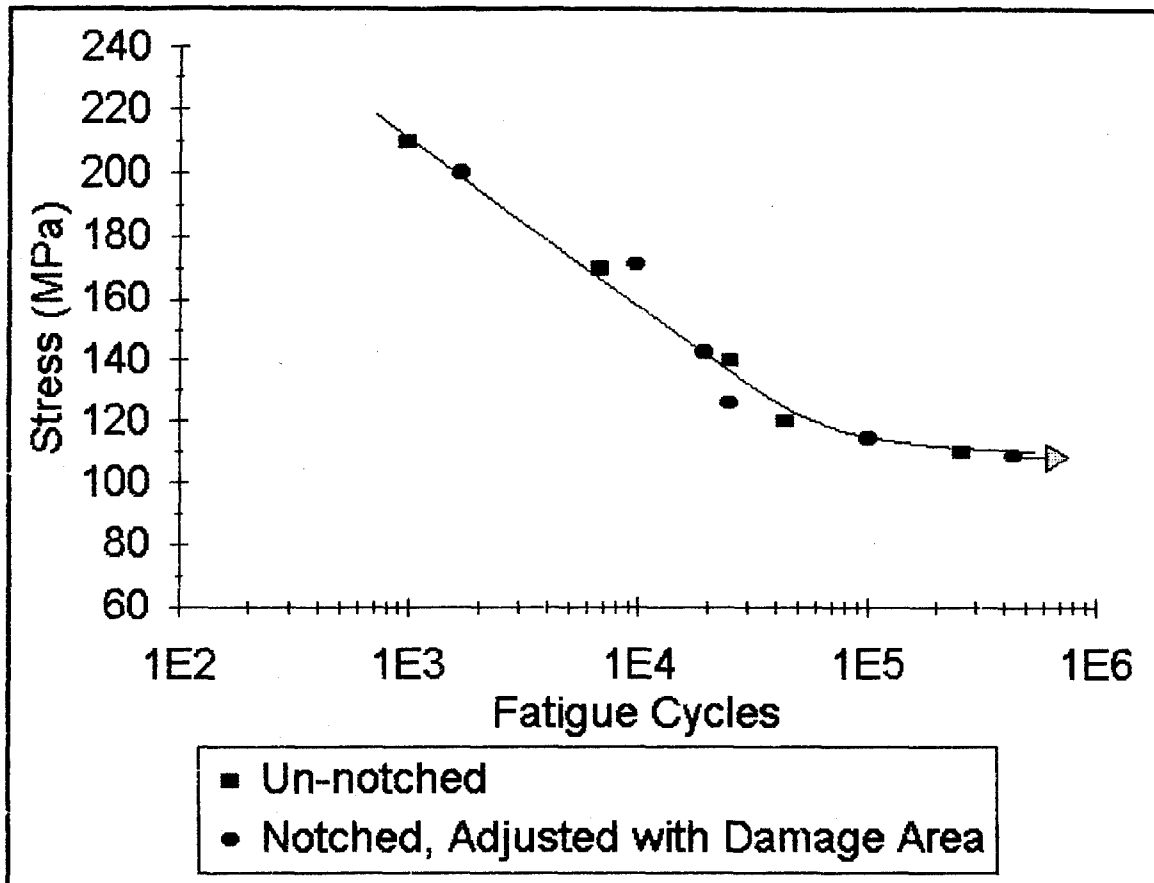
Figure 4-42 S-N Curves for Unnotched and Notched Adjusted With Damage Area

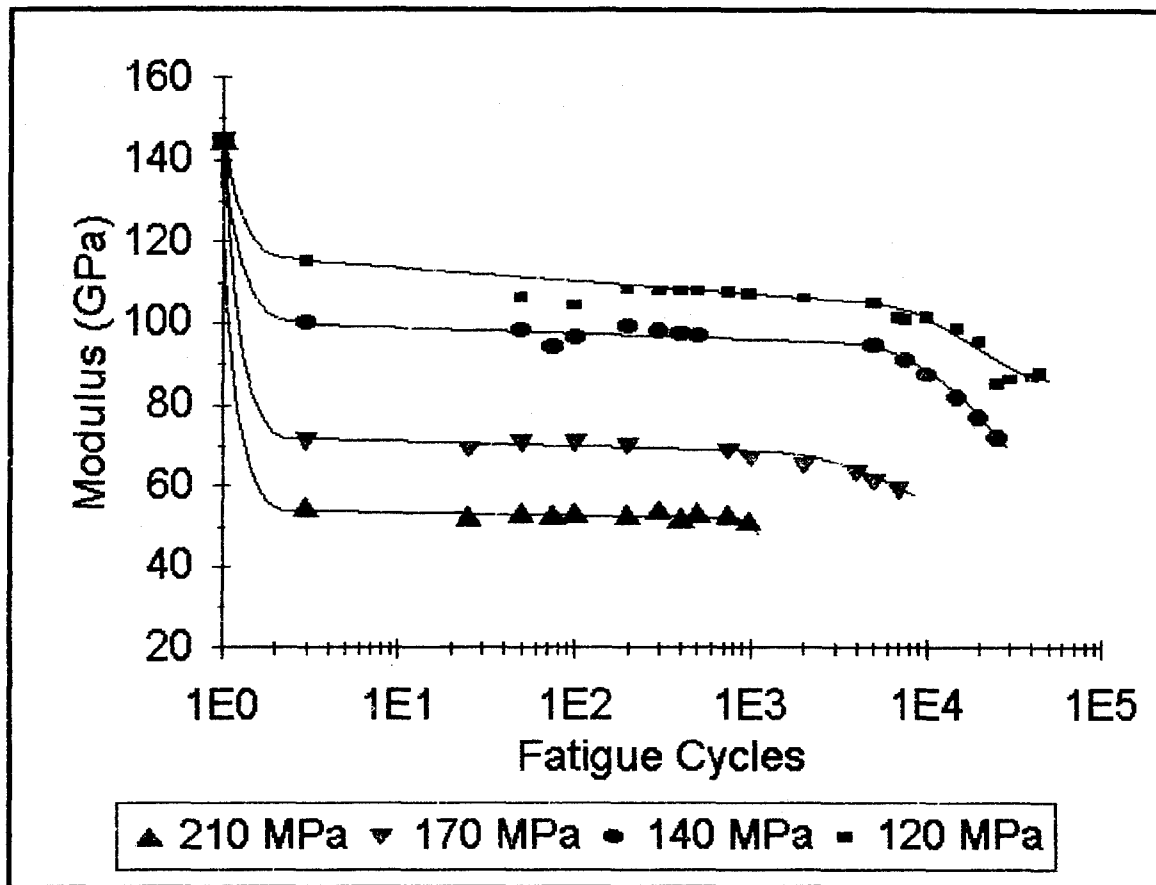
Figure 4-43 Modulus Reduction of Unnotched Specimens

First, the modulus behavior of the unnotched specimens is presented in Figure 4-43 followed by stiffness behavior of the

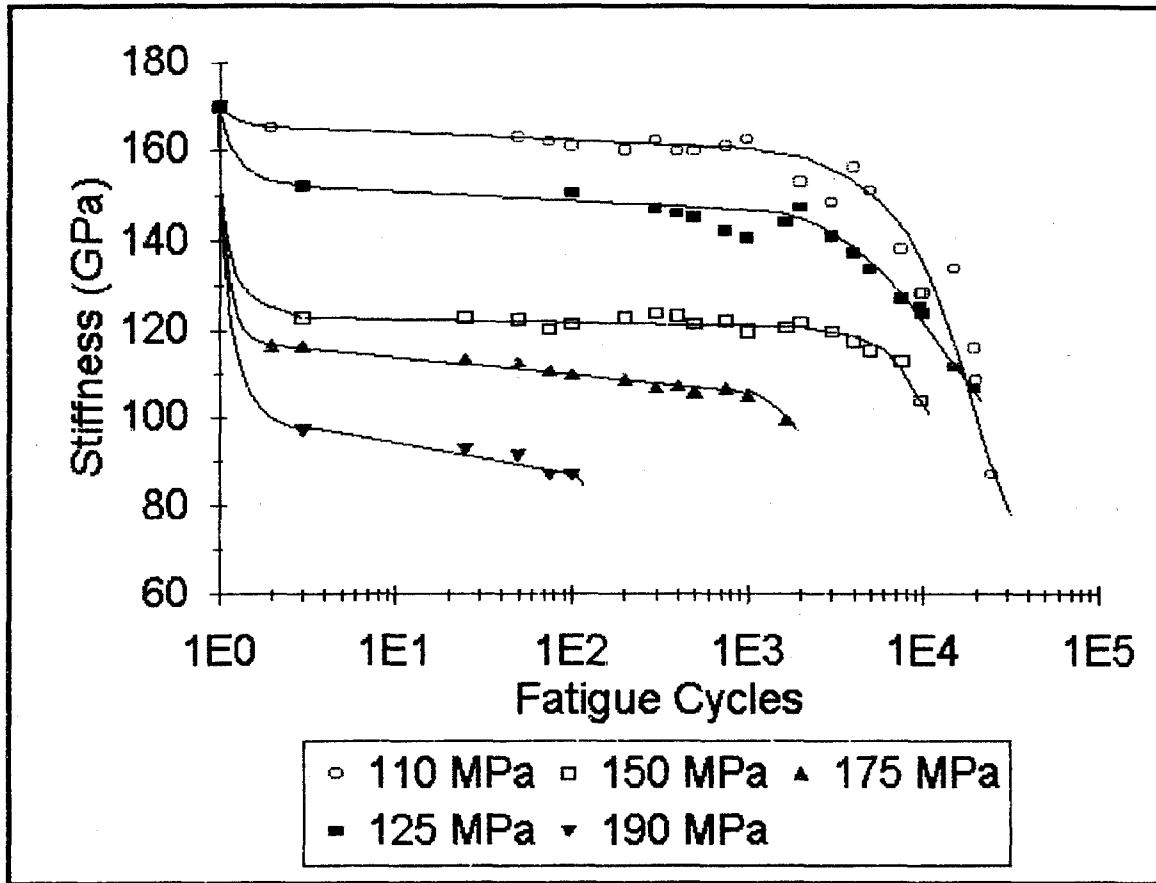
Figure 4-44 Stiffness Reduction, Notched Comparison

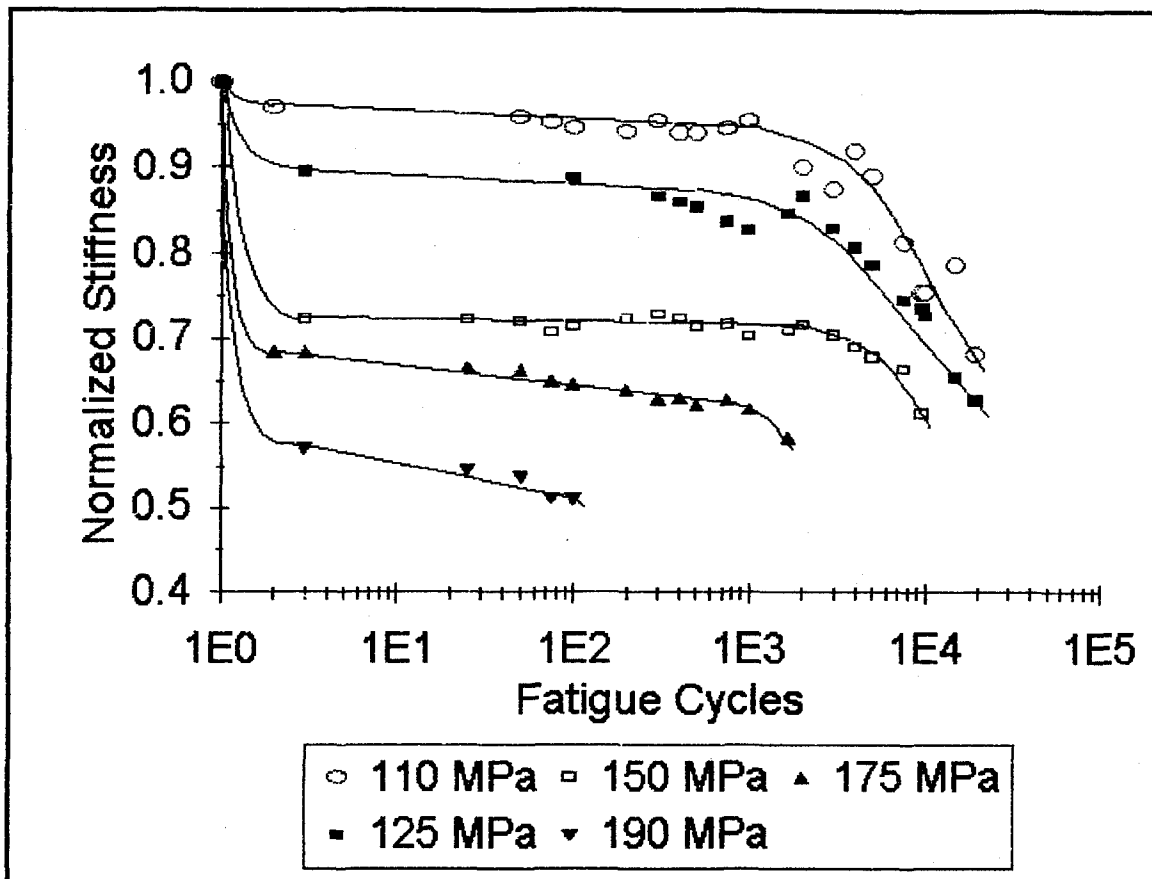
Figure 4-46 Normalized Stiffness Reduction, Notched Fatigue Test Comparison

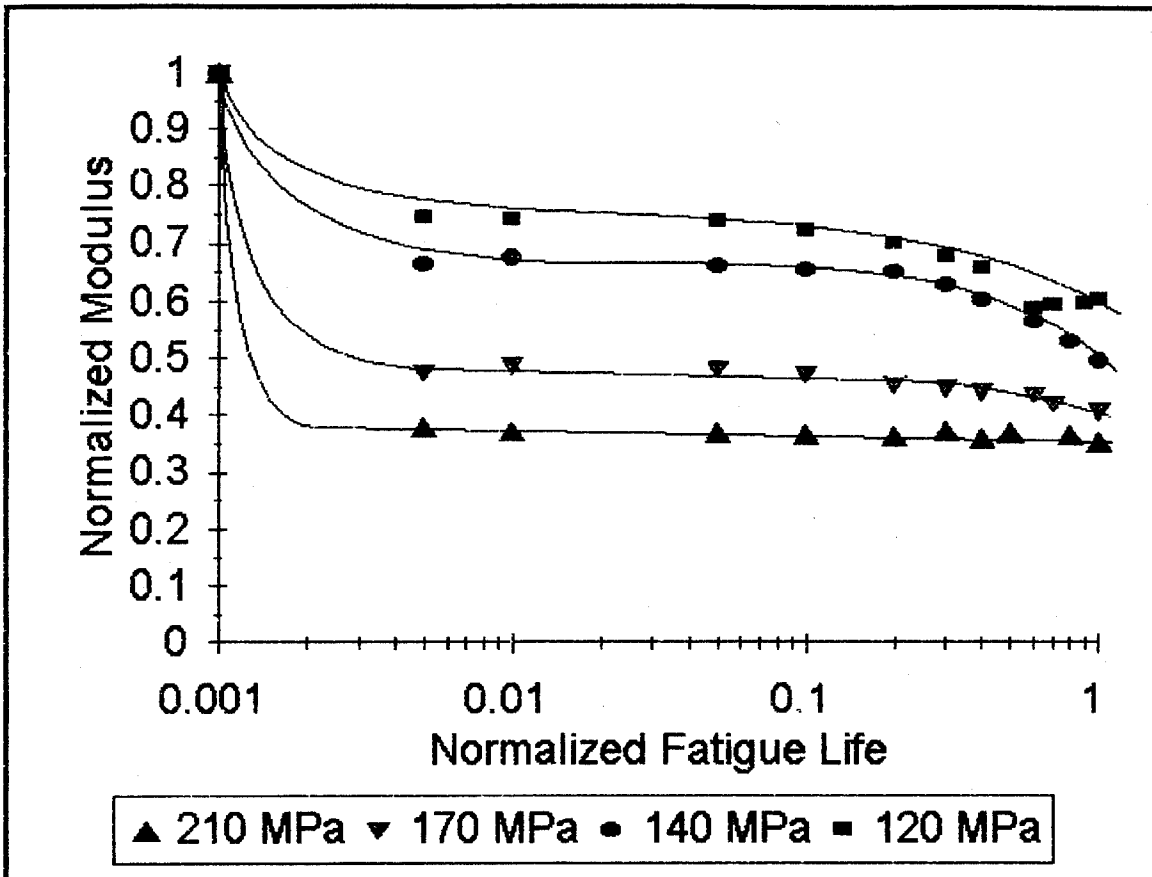
Figure 4-47 Normalized Unnotched Modulus Reduction Vs. Normalized Cycles to Failure, Log Scale

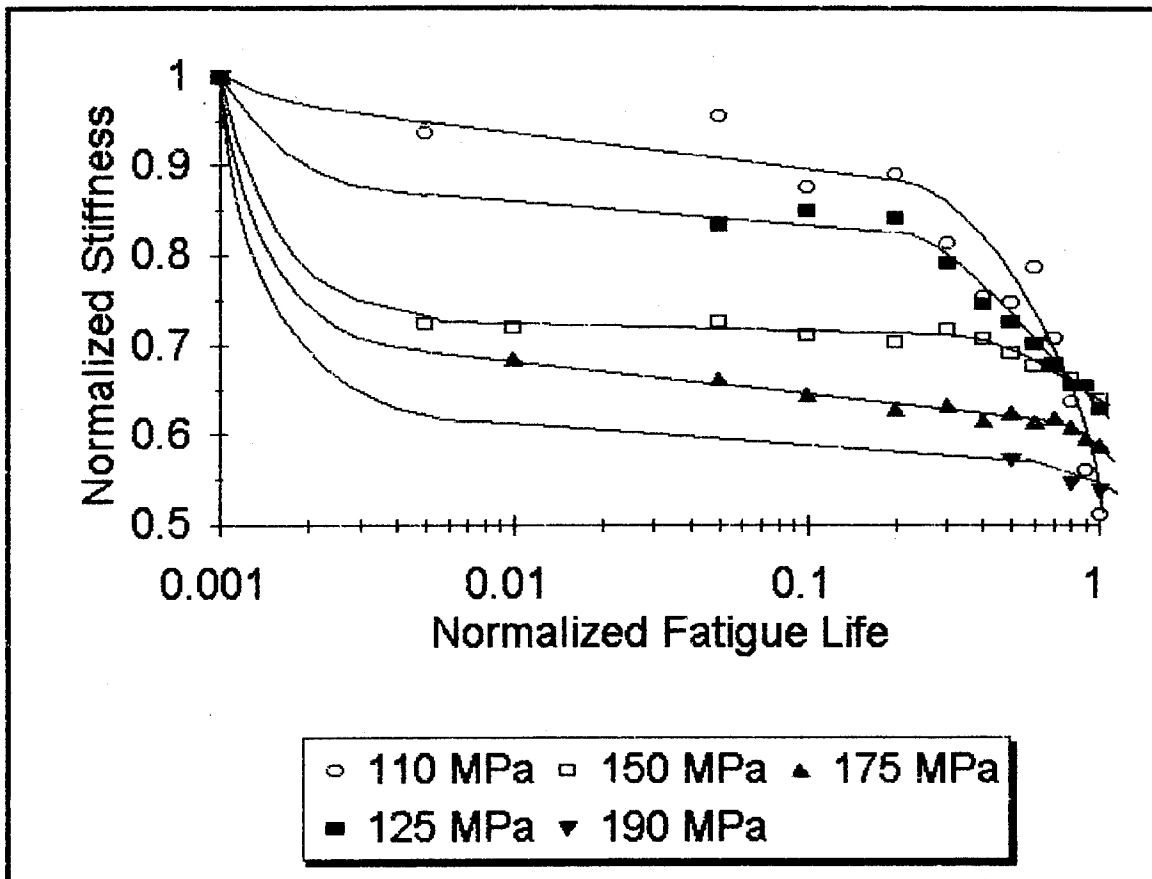
Figure 4-48 Normalized Notched Stiffness Reduction Vs. Normalized Cycles to Failure, Log Scale

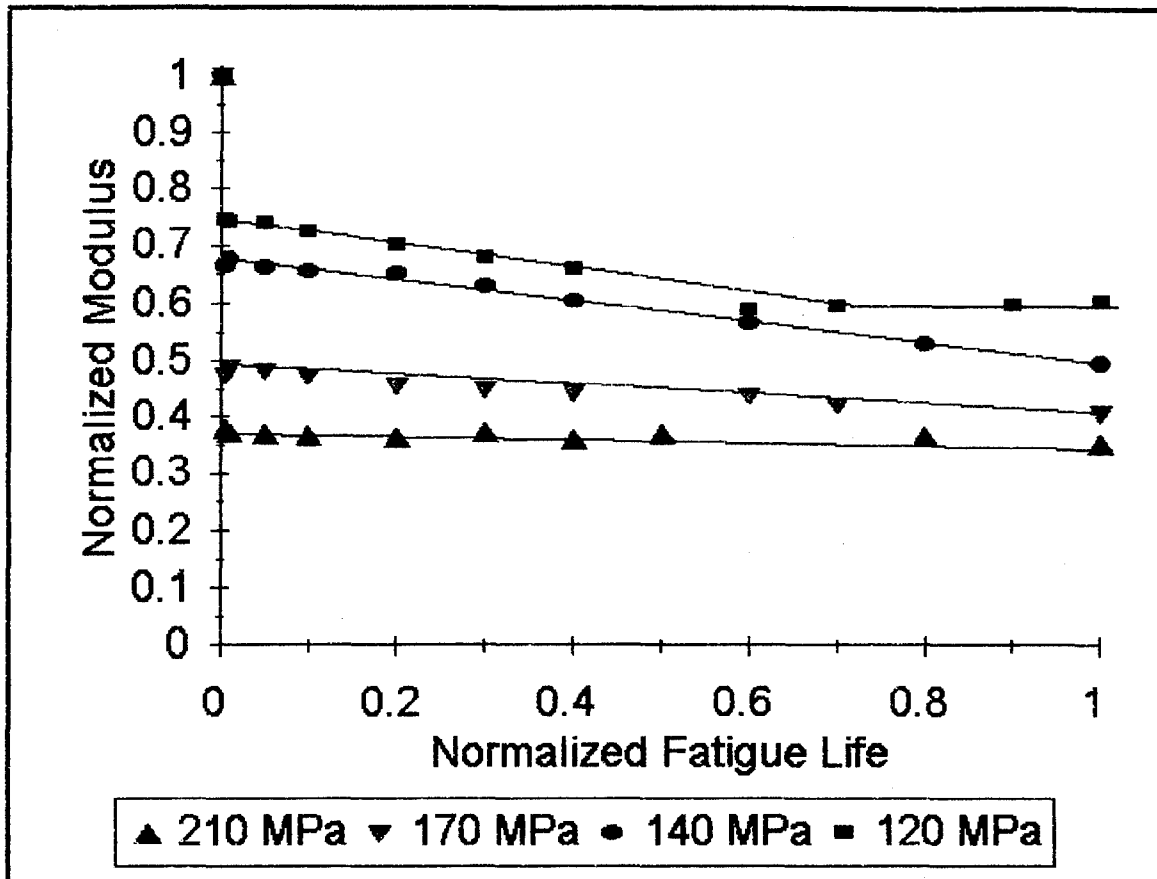
Figure 4-49 Normalized Unnotched Modulus Reduction on a Non Log Scale

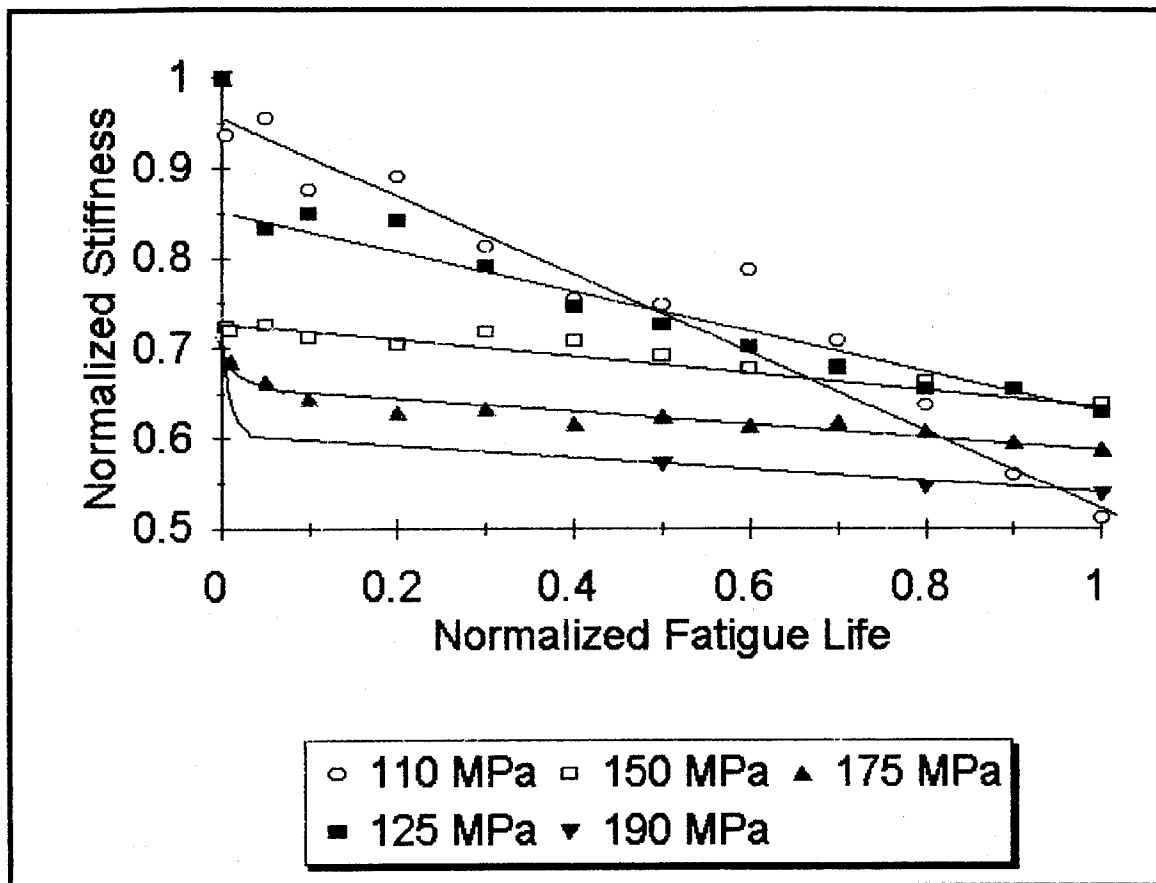
Figure 4-50 Normalized Notched Stiffness Reduction Vs. Normalized Cycles to Failure, Non-Log Scale
